Model 117, 118, 156, 164, 166, 167, 172, 176, 177, 190, 197, 204, 205, 207, 212, 213, 216, 217, 218, 221, 222, 231, 238, 242, 243, 246, 247, 251, 253, 257, 290, 292, 293

P54 21-A006-06

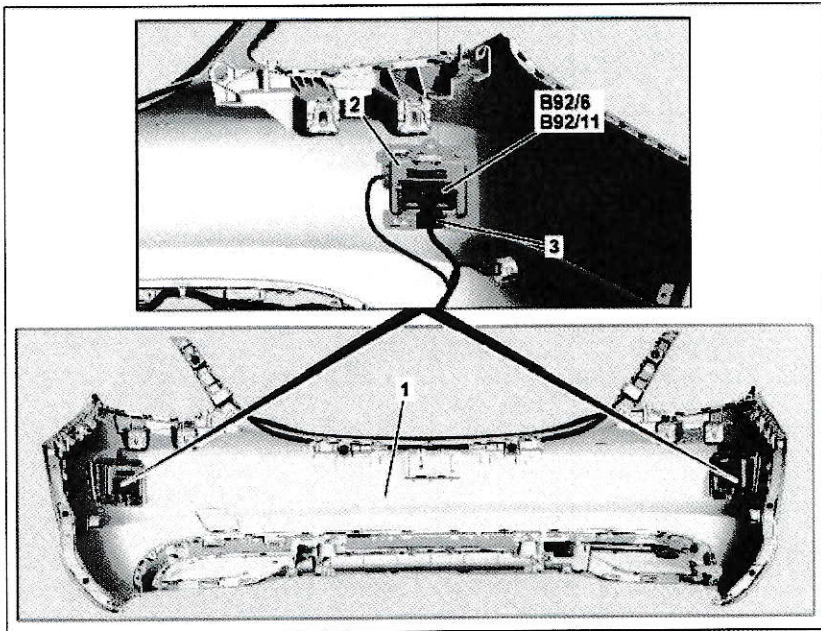
Shown on rear bumper

B92/6 Radar sensor
B92/11 Radar sensor

ⓘ The following notes must be observed on all vehicles. Malfunctions can occur otherwise.

- **One** instance of paintwork rectification in the area of the radar sensors is permissible.
- Before painting, mask off the inside of the bumper in the area of the radar sensors to avoid any paint residue.

ⓘ With code 234 (Blind Spot Assist) or code 233 (Adaptive Cruise Control Plus (DISTRONIC PLUS)) or code 237 (Active Blind Spot Assist) or code 238 (Active Lane Keeping Assist) or code 253 (Rear collision warning and protection system) The following note must be observed on vehicles equipped with the special equipment listed:

- The masking must be removed from the inner side after the painting process. All other residue on the inner side must be removed using a suitable adhesive cleaner or silicone remover.
- Filling and repair work in the area of the radar sensors is **not permissible**.
- Grinding work on the inside of the bumper in the area of the radar sensors is **not permissible**.
- **Two** instances of paintwork rectification in the area of the radar sensors are permissible.
